Container Security – How secure is your product in refurbished containers

Global Logistics Management

Newsletter Date
6 October 2014

Case Study

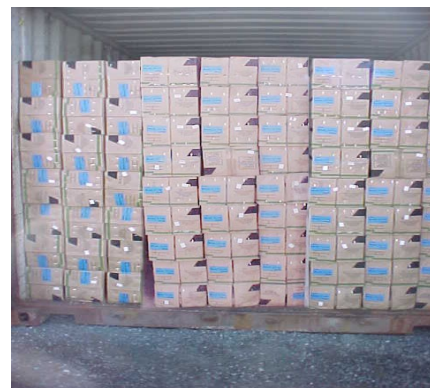
The following morning the container seals were again checked by site staff and found to be intact. The first container seal was cut and the doors opened. According to documents this container held 750 boxes of Class 1 Explosives. All looked well and unloading commenced. After removal of some of the centre stacks of boxes it was noticed that the remaining stacks were not as high as those just removed, and that there was empty floor space in the centre of the container. It was immediately apparent that this container did not contain the quantity of boxes specified on the documentation. A box count indicated a substantial discrepancy between documents and contents.

Pic 1. Reconstruction of view of the boxes when the container doors were opened on the first container.

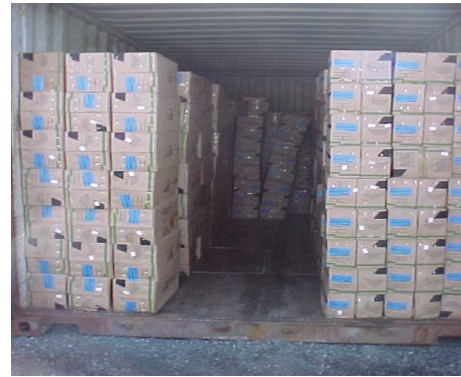
Pic 2. View inside container still on site after six of the centre stacks (54 boxes) were unloaded exposing empty space inside and a stack plus other boxes missing at the far end of the container.

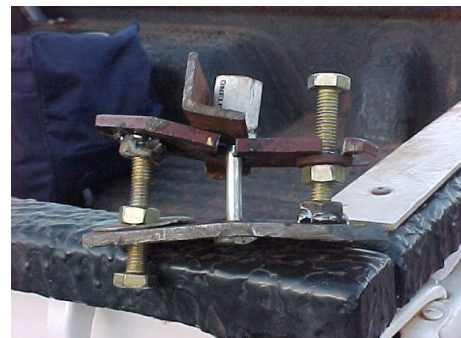
With the limited resources available at the site workshop a rather primitive, but workable, 'puller' device was constructed however, no successful separations were achieved on the seals tested. The locking chamber coverings were damaged on each of the seals.

Pic 3. Primitive 'puller' constructed in an attempt to separate the locking chamber from the shaft.

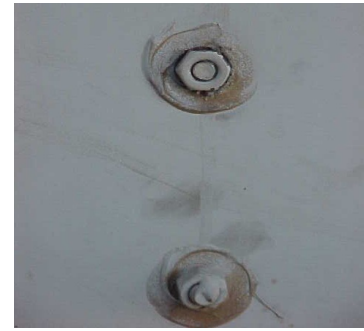
The following morning a closer examination of the container was carried out. Again, nothing untoward was seen on the outside. The inside of the door told a different story. The various bolts retaining the door hardware were painted over and in some cases the ends of the bolts were spot welded to the nut however, the nut holding the door locking handle retainer appeared to have been tampered with. Paint was missing from the end of the nut/bolt and its appearance indicated that the nut had been removed at some stage (see Pic 4). The nut was embedded in a putty like substance. The bolt was a hex bolt and not a mushroom head indicating that the mechanism had been subject to some sort of maintenance.

Given the status of the nut it was suggested that the door locking retainer bolt may have been removed to gain access to the container. This simple mechanism appeared to be the weak link. This theory was tested.

Pic 4. Back of the container door showing the door locking handle retainer bolt/nut. The nut appeared to have been tampered with.

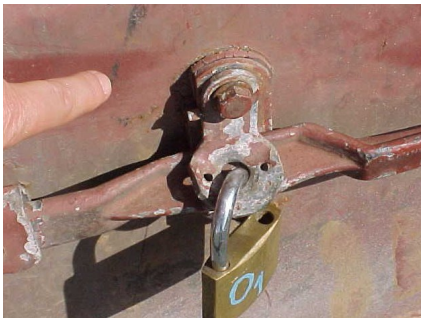
The padlock, which at that time was being used to lock the container doors, remained attached to the retainer and handle and was completely ineffective in preventing the door from being opened. See Pics 5, 6, 7, 8 and 9. This would also have been the case had a bolt seal been in the mechanism.

Pic 5. Locking handle retainer with hex bolt.

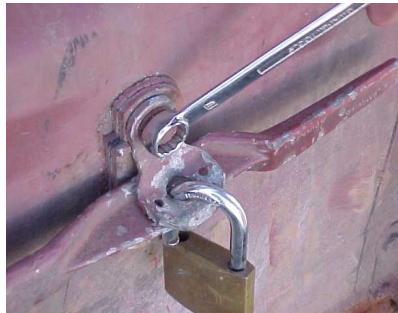
Using a spanner and screwdriver (to keep the nut/bolt taugt) the bolt was extracted fairly easily releasing the handle retainer and allowing the container to be opened.

Pic 6. Bolt being extracted.

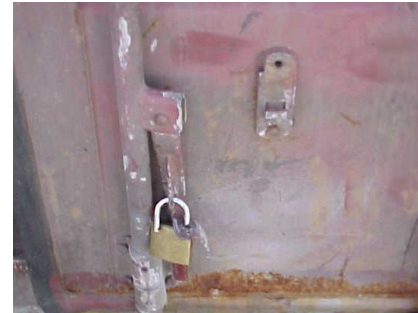
Pic 7. Handle retainer released allowing door to be opened.

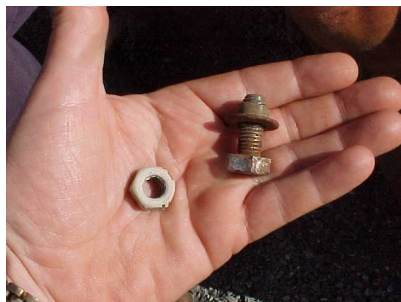
Pic 8. Hex bolt and nut removed from the locking handle retainer.

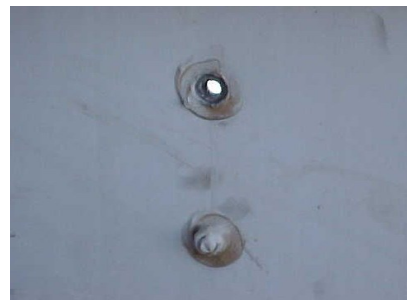
Pic 9. Bolt and nut removed. Slightly raised putty like substance can be seen around the hole.

The nut was then repositioned at the hole at the back of the container door and held in position by the putty like substance, door closed, retainer put in place and the bolt screwed back. It took several attempts before the bolt/nut threads connected and the bolt/nut tightened.

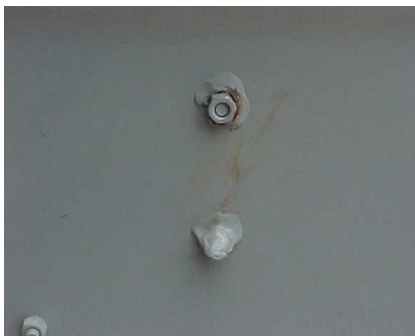
Pic 10. Container at depot. Door locking handle retainer nut/bolt. Damaged putty like material around the nut

The retainer nut on one of the containers was embedded in a hardened grey putty like substance similar to the covering over the nut immediately below it — see Pic 10. From its appearance it looked like the retainer nut may also have been completely covered at some point and that the substance was damaged due to the nut being turned. This substance was similar to that seen on the breached container at the importers site. The nuts on the handle retainers on the other two containers had a white substance around them, as depicted in Pics 11 and 12. Both had paint missing from the bolt threads.

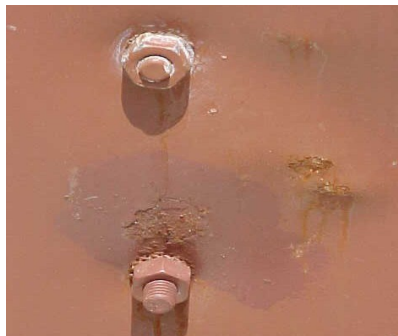
Pic 11. Container at Depot. Door locking handle retainer nut/bolt. Paint missing from the bolt threads and unknown residue on the nut.

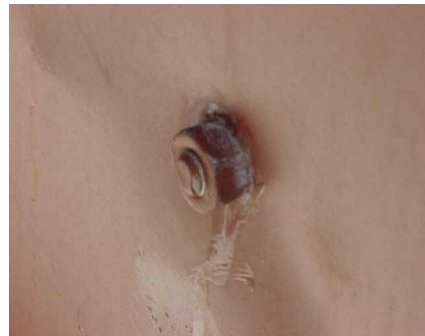
Pic 12. Container at depot. Door locking handle retainer nut/bolt. Paint missing from the bolt threads and unknown residue on the nut.

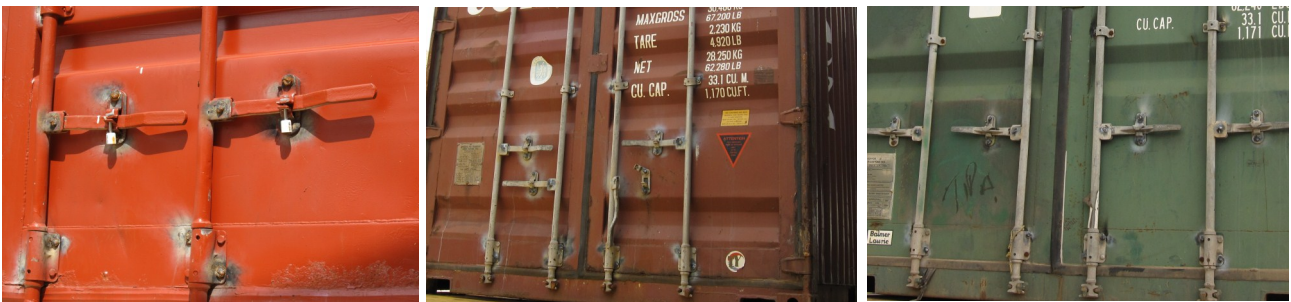
Pics 13, 14 and 15. Spot welding of bolts on the outside of purchased containers to enhance security and prevent bolts from being removed to gain entry to the containers.

The exporter, who maintained high standards where security of their product was concerned, went one step further by instituting spot welding of nuts/bolts, not only on the inside of the container doors, but also on the outside of all containers they purchased.

The exporter's container inspection check sheets were amended to include confirmation that the above had been carried out prior to the loading of containers, irrespective of the type of product being loaded. See Pics 13, 14 and 15.
